AHERA Inspection

Oasis Elementary School North 2817 SW 3rd Lane Cape Coral, Florida 33991

Report Number: 23-060217-AS
Prepared On: July 6, 2023

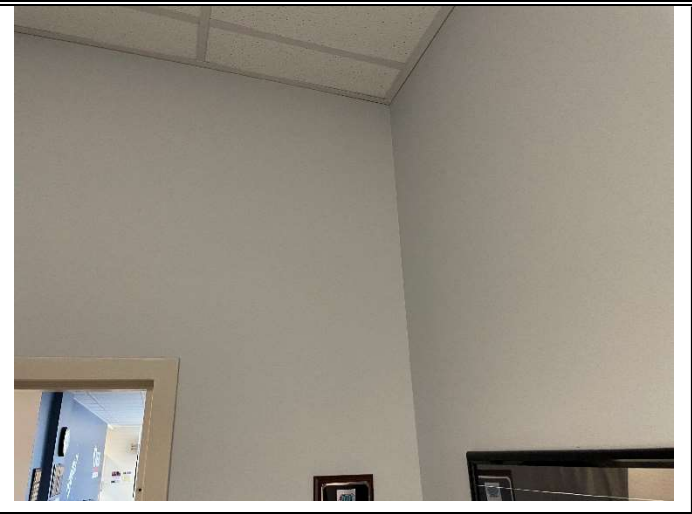
| Table 1. Assumed Suspect Asbestos-Containing Materials | | | | | | | |
|---|---|---|---|---|---|---|---|
| A | Drywall/Joint Compound, White | Administration Building | Good | Friable | Low | One | Seven |

Photo 2: HM-A: Drywall/Joint Compound, White

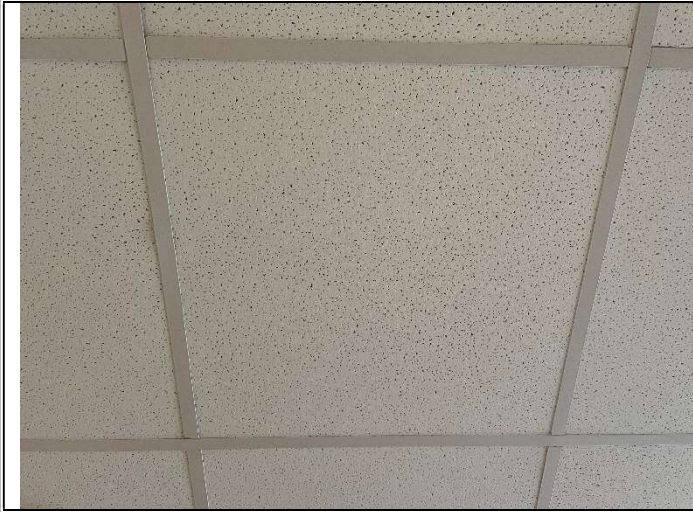
| Table 1. Assumed Suspect Asbestos-Containing Materials | | | | | | | |
|---|---|---|---|---|---|---|---|
| B | 2' x 2' Ceiling Tile, White Pinhole | Administration Building | Good | Friable | Low | One | Seven |

Photo 3: HM-B: 2' x 2' Ceiling Tile, White Pinhole

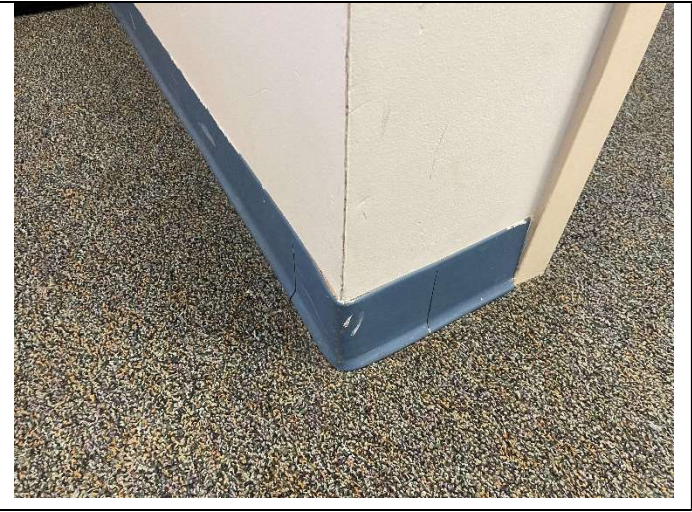
| Table 1. Assumed Suspect Asbestos-Containing Materials | | | | | | | |
|---|---|---|---|---|---|---|---|
| C | Cove Base/Mastic, Blue/Tan | Administration Building | Good | Non- Friable | Low | One | Seven |

Photo 4: HM-C: Cove Base/Mastic, Blue/Tan

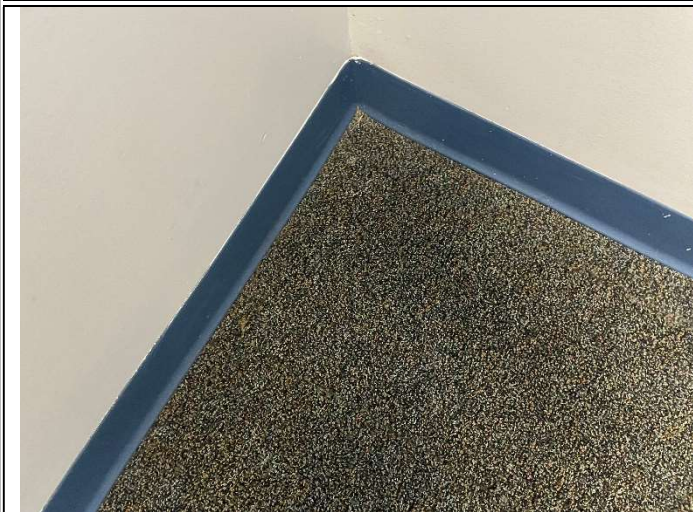
| Table 1. Assumed Suspect Asbestos-Containing Materials | | | | | | | |
|---|---|---|---|---|---|---|---|
| D | Carpet Mastic, Yellow | Administration Building | Good | Non- Friable | Low | One | Seven |

Photo 5: HM-D: Carpet Mastic, Yellow

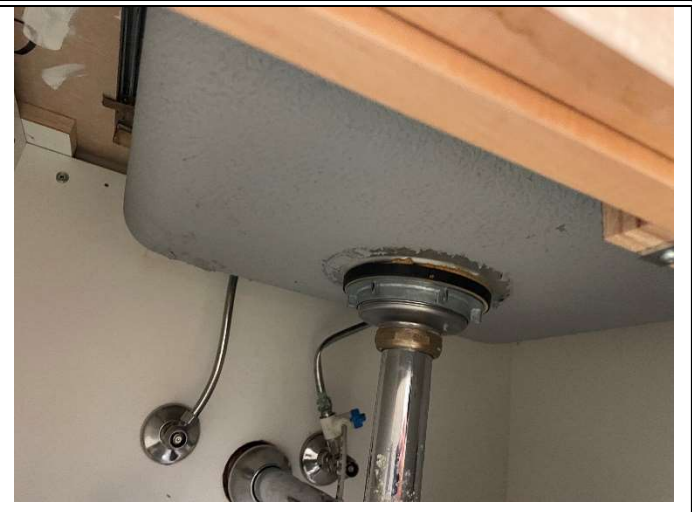
| Table 1. Assumed Suspect Asbestos-Containing Materials | | | | | | | |
|---|---|---|---|---|---|---|---|
| E | Sink Insulation, Gray | Administration Building | Good | Non- Friable | Low | One | Seven |

Photo 6: HM-E: Sink Insulation, Gray

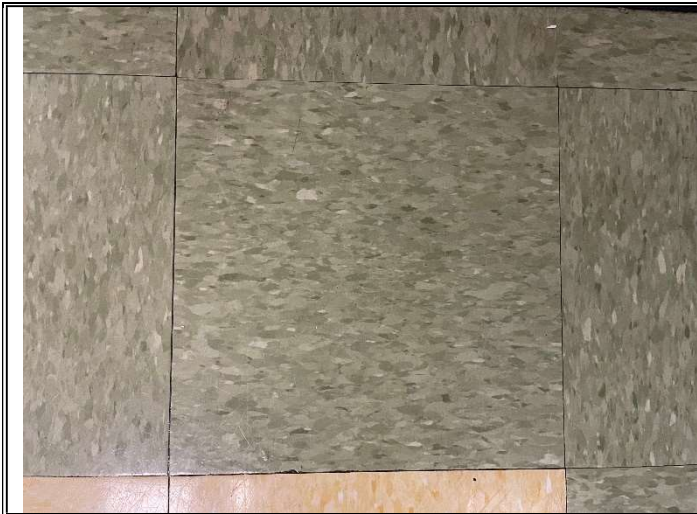
| Table 1. Assumed Suspect Asbestos-Containing Materials | | | | | | | |
|---|---|---|---|---|---|---|---|
| F | 12" x 12" Vinyl Floor Tile, Green | Administration Building | Good | Non- Friable | Low | One | Seven |

Photo 7: HM-F: 12" x 12" Vinyl Floor Tile, Green

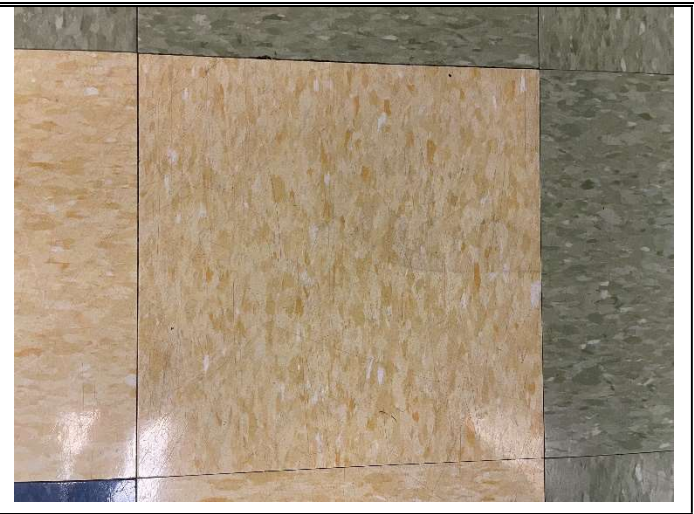
| Table 1. Assumed Suspect Asbestos-Containing Materials | | | | | | | |
|---|---|---|---|---|---|---|---|
| G | 12" x 12" Vinyl Floor Tile, Tan | Administration Building | Good | Non- Friable | Low | One | Seven |

Photo 8: HM-G: 12" x 12" Vinyl Floor Tile, Tan

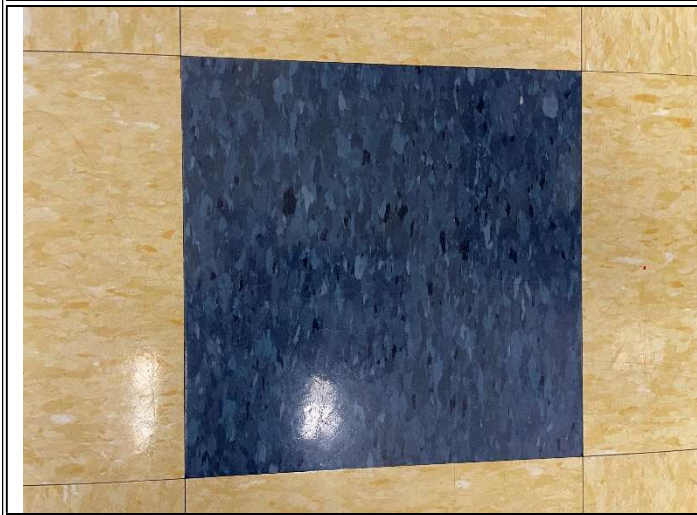
| Table 1. Assumed Suspect Asbestos-Containing Materials | | | | | | | |
|---|---|---|---|---|---|---|---|
| H | 12" x 12" Vinyl Floor Tile, Navy Blue | Administration Building | Good | Non- Friable | Low | One | Seven |

Photo 9: HM-H: 12" x 12" Vinyl Floor Tile, Navy Blue

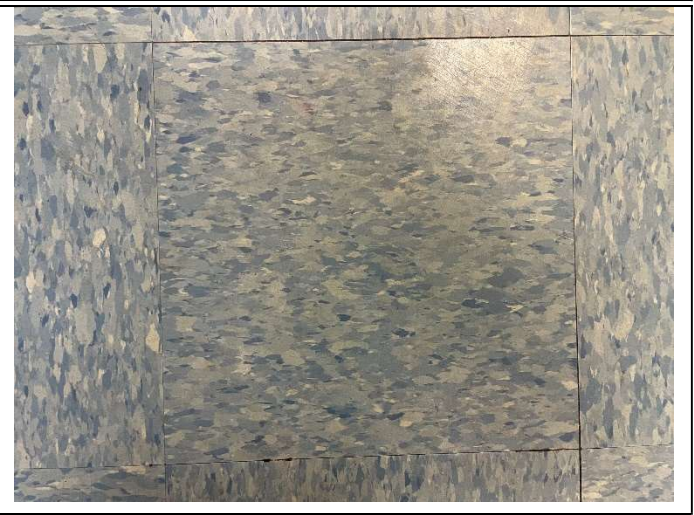
| Table 1. Assumed Suspect Asbestos-Containing Materials | | | | | | | |
|---|---|---|---|---|---|---|---|
| I | 12" x 12" Vinyl Floor Tile, Light Blue | Administration Building | Good | Non- Friable | Low | One | Seven |

Photo 10: HM-I: 12" x 12" Vinyl Floor Tile, Light Blue

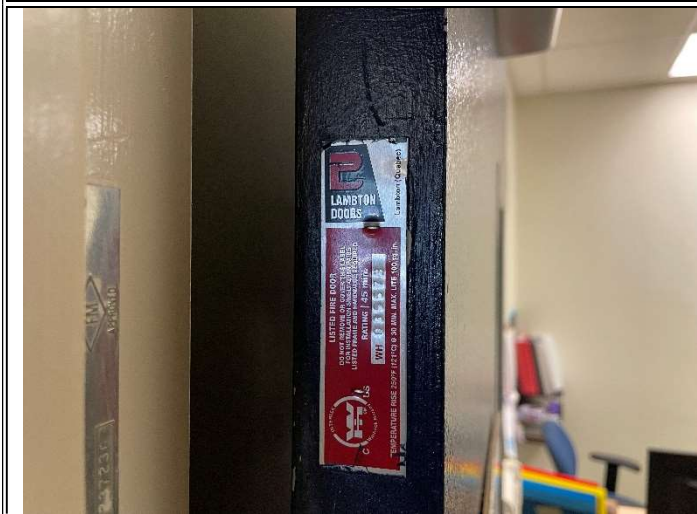
| Table 1. Assumed Suspect Asbestos-Containing Materials | | | | | | | |
|---|---|---|---|---|---|---|---|
| J | Fire-rated Door Insulation, Red Tag with Silver Lettering | Administration Building | Good | Friable | Low | One | Seven |

Photo 11: HM-J: Fire-rated Door Insulation, Red Tag with Silver Lettering

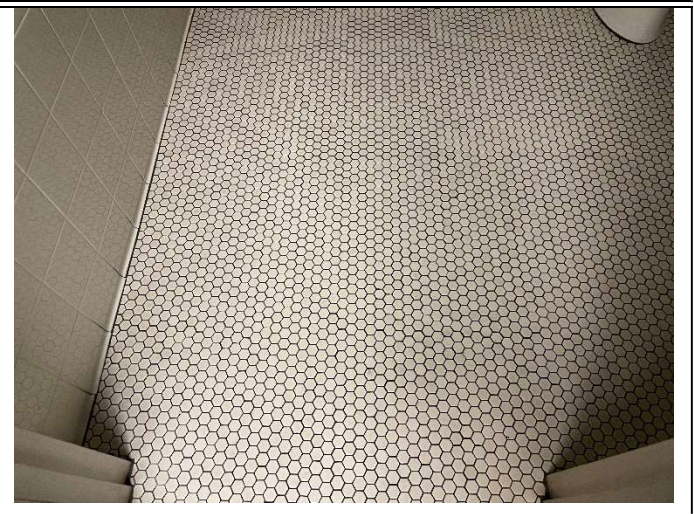
| Table 1. Assumed Suspect Asbestos-Containing Materials | | | | | | | |
|---|---|---|---|---|---|---|---|
| K | Hexagon Ceramic Tile, White | Administration Building | Good | Non- Friable | Low | One | Seven |

Photo 12: HM-K: Hexagon Ceramic Tile, White

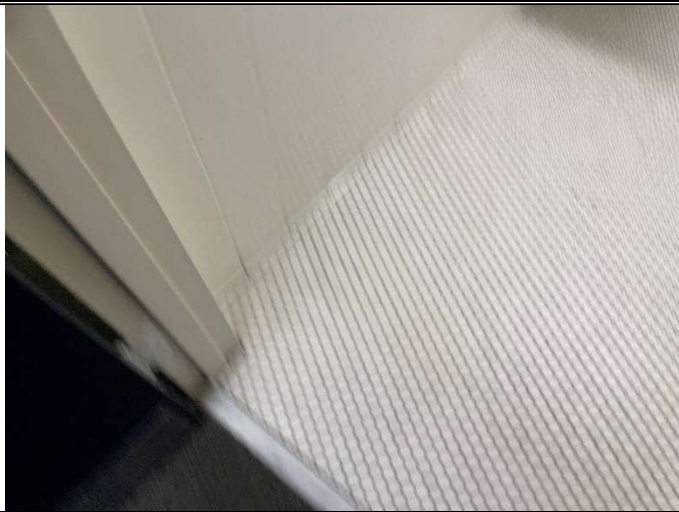
| Table 1. Assumed Suspect Asbestos-Containing Materials | | | | | | | |
|---|---|---|---|---|---|---|---|
| L | 6" Ceramic Wall Tile, White | Administration Building | Good | Non- Friable | Low | One | Seven |

Photo 13: HM-L: 6" Ceramic Wall Tile, White

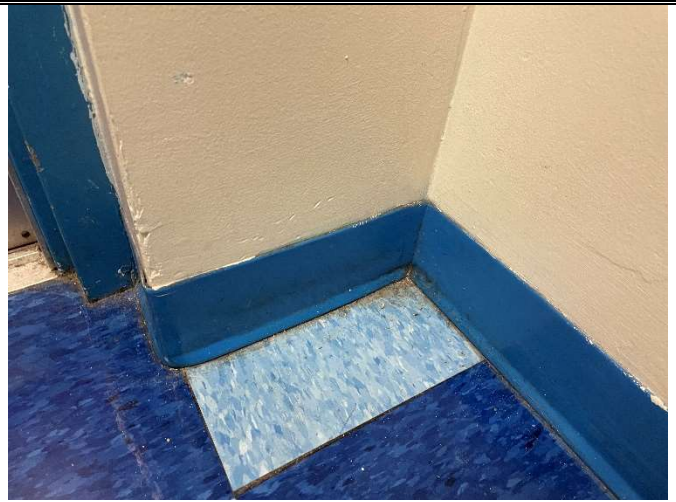
| Table 1. Assumed Suspect Asbestos-Containing Materials | | | | | | | |
|---|---|---|---|---|---|---|---|
| M | Cove Base/Mastic, Royal Blue | Administration Building-Cafe | Good | Non- Friable | Low | One | Seven |

Photo 14: HM-M: Cove Base/Mastic, Royal Blue

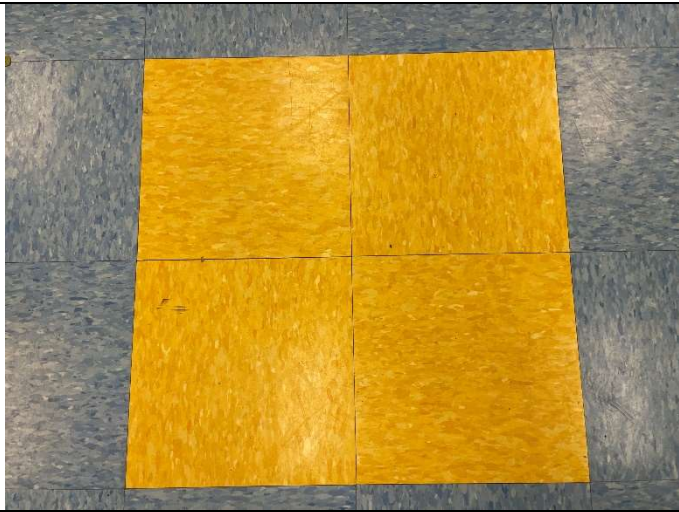
| Table 1. Assumed Suspect Asbestos-Containing Materials | | | | | | | |
|---|---|---|---|---|---|---|---|
| N | 12" x 12" Vinyl Floor Tile, Yellow | Administration Building-Cafe | Good | Non- Friable | Low | One | Seven |

Photo 15: HM-N: 12" x 12" Vinyl Floor Tile, Yellow

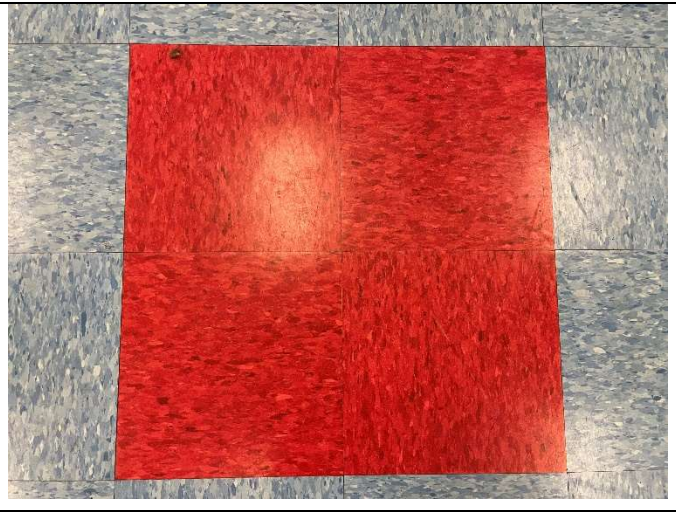
| Homog. Material | Material Description/Color | Material Location | Material Condition | Friability | Potential for Disturbance | Hazard Rank | Removal Rank |
|---|---|---|---|---|---|---|---|
| O | 12" x 12" Vinyl Floor Tile, Red | Administration Building-Cafe | Good | Non- Friable | Low | One | Seven |

Photo 16: HM-O: 12" x 12" Vinyl Floor Tile, Red

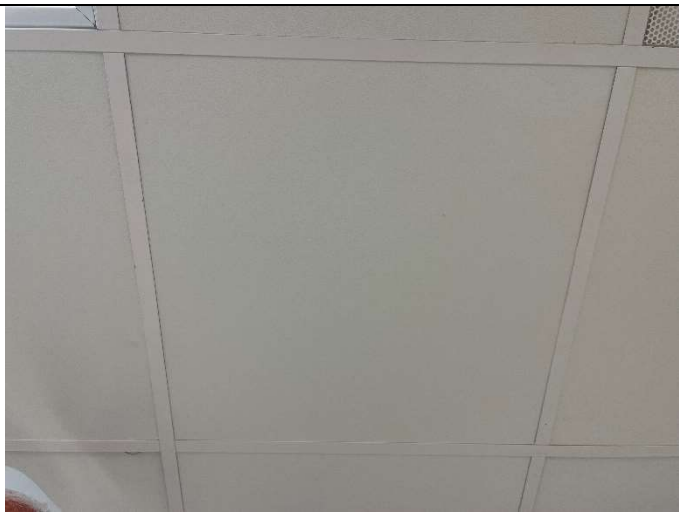
| Homog. Material | Material Description/Color | Material Location | Material Condition | Friability | Potential for Disturbance | Hazard Rank | Removal Rank |
|---|---|---|---|---|---|---|---|
| P | 2' x 2' Drywall Ceiling Tile, White | Administration Building-Kitchen | Good | Friable | Low | One | Seven |

Photo 17: HM-P: 2' x 2' Drywall Ceiling Tile, White

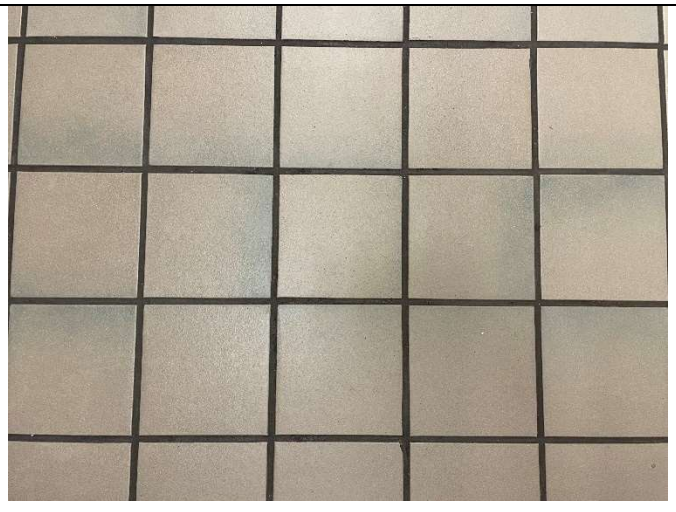
| Homog. Material | Material Description/Color | Material Location | Material Condition | Friability | Potential for Disturbance | Hazard Rank | Removal Rank |
|---|---|---|---|---|---|---|---|
| Q | 4" Ceramic Tile, Gray | Administration Building-Kitchen | Good | Non- Friable | Low | One | Seven |

Photo 18: HM-Q: 4" Ceramic Tile, Gray

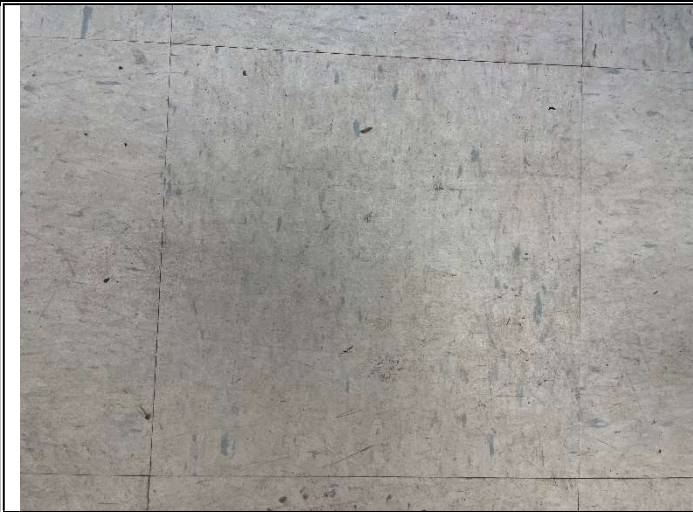
| Homog. Material | Material Description/Color | Material Location | Material Condition | Friability | Potential for Disturbance | Hazard Rank | Removal Rank |
|---|---|---|---|---|---|---|---|
| R | 12" x 12" Vinyl Floor Tile, White/Blue Speckles | Administration Building-Storage | Good | Non- Friable | Low | One | Seven |

Photo 19: HM-R: 12" x 12" Vinyl Floor Tile, White/Blue Speckles

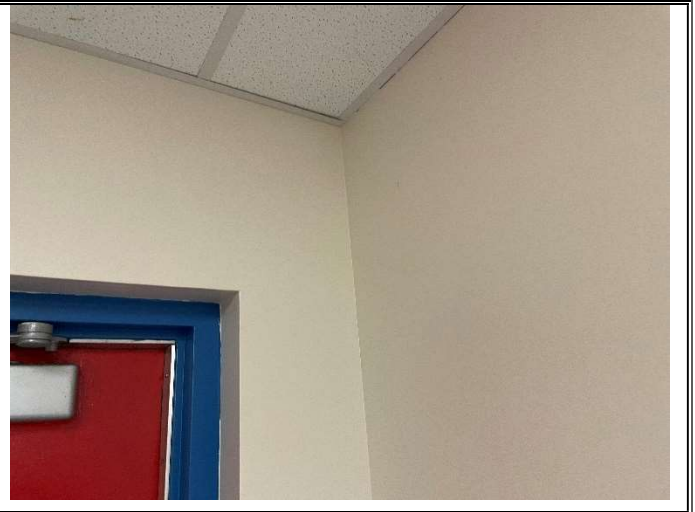
| Homog. Material | Material Description/Color | Material Location | Material Condition | Friability | Potential for Disturbance | Hazard Rank | Removal Rank |
|---|---|---|---|---|---|---|---|
| S | Drywall/Joint Compound, White | Classroom Building | Good | Friable | Low | One | Seven |

Photo 20: HM-S: Drywall/Joint Compound, White

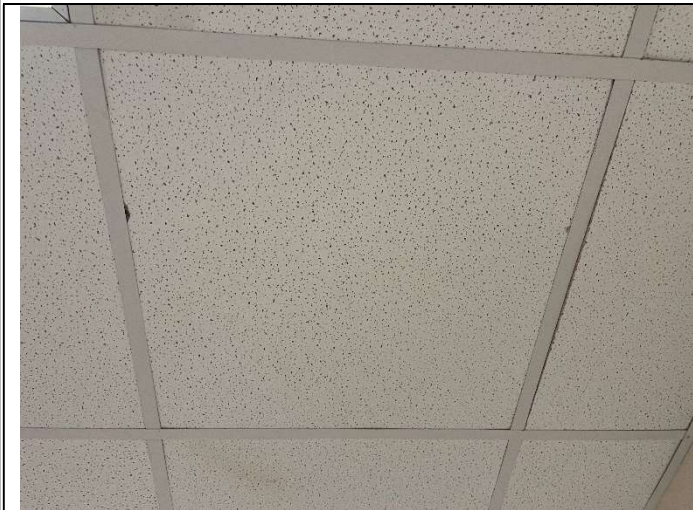
| Homog. Material | Material Description/Color | Material Location | Material Condition | Friability | Potential for Disturbance | Hazard Rank | Removal Rank |
|---|---|---|---|---|---|---|---|
| T | 2' x 2' Ceiling Tile, White Pinhole | Classroom Building | Good | Non- Friable | Low | One | Seven |

Photo 21: HM-T: 2' x 2' Ceiling Tile, White Pinhole

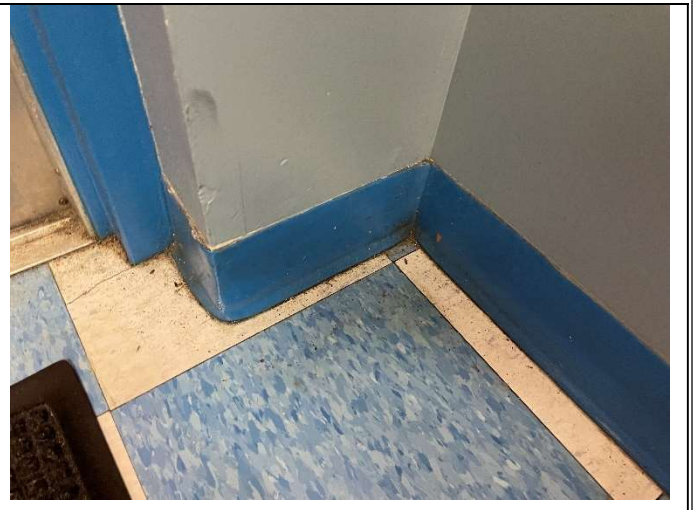
| Homog. Material | Material Description/Color | Material Location | Material Condition | Friability | Potential for Disturbance | Hazard Rank | Removal Rank |
|---|---|---|---|---|---|---|---|
| U | 12" x 12" Vinyl Floor Tile, Royal Blue | Classroom Building | Good | Non- Friable | Low | One | Seven |

Photo 22: HM-U: 12" x 12" Vinyl Floor Tile, Royal Blue

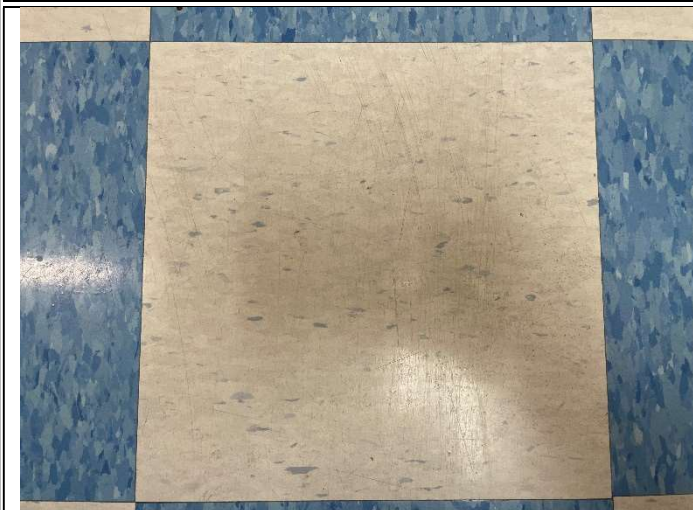
| Homog. Material | Material Description/Color | Material Location | Material Condition | Friability | Potential for Disturbance | Hazard Rank | Removal Rank |
|---|---|---|---|---|---|---|---|
| V | 12" x 12" Vinyl Floor Tile, White/Blue Speckles | Classroom Building | Good | Non- Friable | Low | One | Seven |

Photo 23: HM-V: 12" x 12" Vinyl Floor Tile, White/Blue Speckles

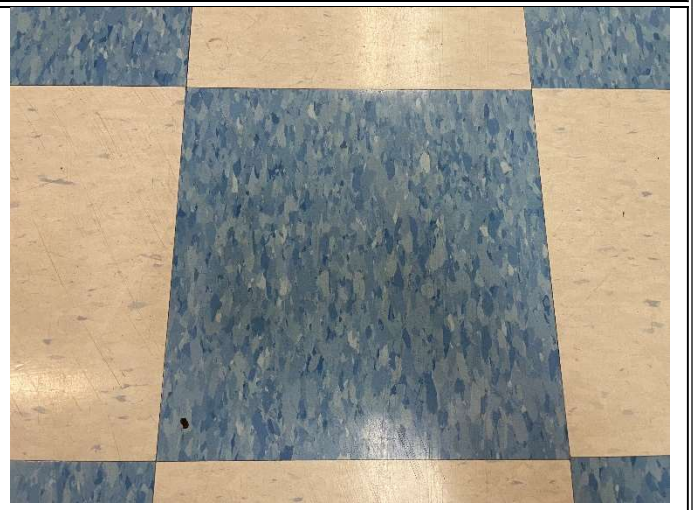
| Homog. Material | Material Description/Color | Material Location | Material Condition | Friability | Potential for Disturbance | Hazard Rank | Removal Rank |
|---|---|---|---|---|---|---|---|
| W | 12" x 12" Vinyl Floor Tile, Light Blue | Classroom Building | Good | Non- Friable | Low | One | Seven |

Photo 24: HM-W: 12" x 12" Vinyl Floor Tile, Light Blue

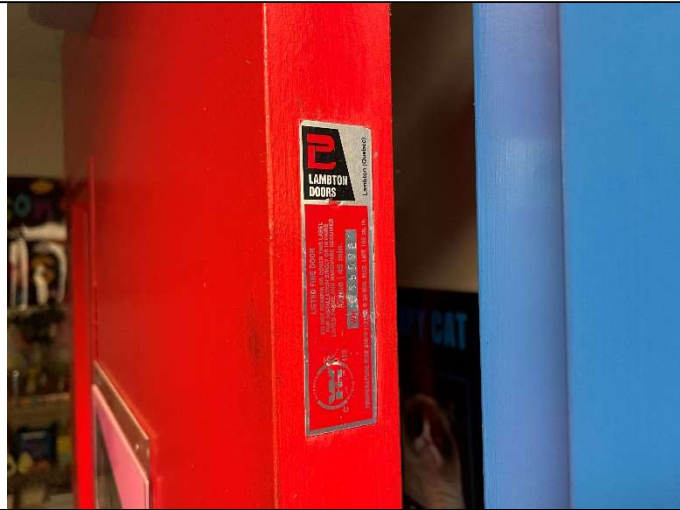
| Homog. Material | Material Description/Color | Material Location | Material Condition | Friability | Potential for Disturbance | Hazard Rank | Removal Rank |
|---|---|---|---|---|---|---|---|
| X | Fire-rated Door Insulation, Red Tag with Silver Lettering | Classroom Building | Good | Friable | Low | One | Seven |

Photo 25: HM-X: Fire-rated Door Insulation, Red Tag with Silver Lettering

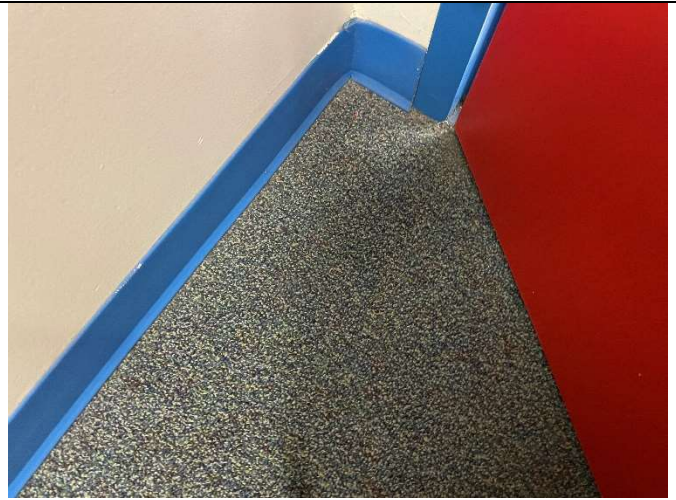
| Homog. Material | Material Description/Color | Material Location | Material Condition | Friability | Potential for Disturbance | Hazard Rank | Removal Rank |
|---|---|---|---|---|---|---|---|
| Y | Carpet Mastic, Tan | Classroom Building | Good | Non- Friable | Low | One | Seven |

Photo 26: HM-Y: Carpet Mastic, Tan

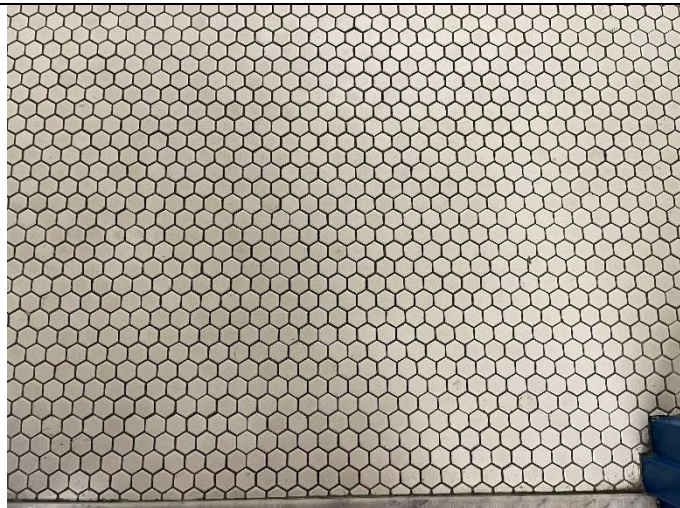
| Homog. Material | Material Description/Color | Material Location | Material Condition | Friability | Potential for Disturbance | Hazard Rank | Removal Rank |
|---|---|---|---|---|---|---|---|
| Z | Hexagon Ceramic Tile, White | Classroom Building | Good | Non- Friable | Low | One | Seven |

Photo 27: HM-Z: Hexagon Ceramic Tile, White

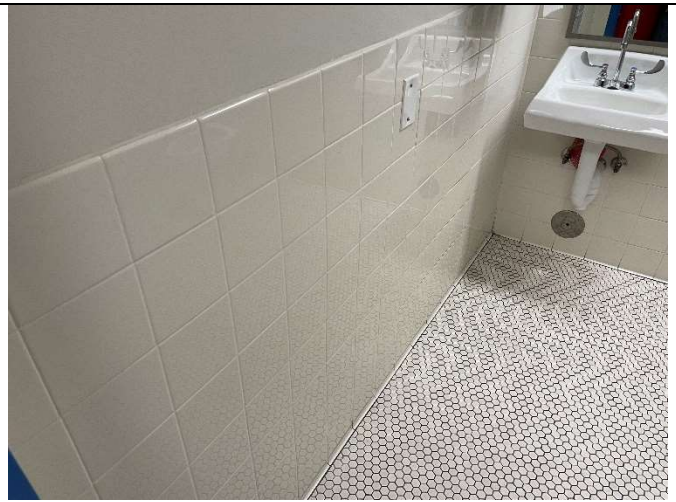
| Homog. Material | Material Description/Color | Material Location | Material Condition | Friability | Potential for Disturbance | Hazard Rank | Removal Rank |
|---|---|---|---|---|---|---|---|
| AA | 6" Ceramic Tile, White | Classroom Building | Good | Non- Friable | Low | One | Seven |

Photo 28: HM-AA: 6" Ceramic Tile, White

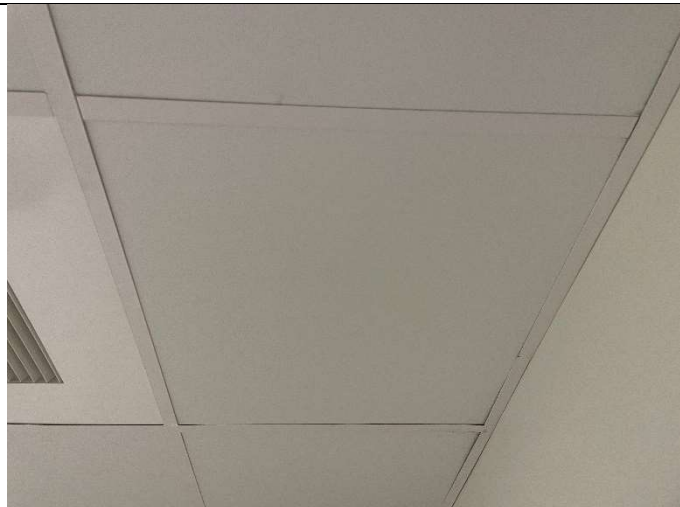
| Homog. Material | Material Description/Color | Material Location | Material Condition | Friability | Potential for Disturbance | Hazard Rank | Removal Rank |
|---|---|---|---|---|---|---|---|
| BB | 2' x 2' Drywall Ceiling Tile, White | Classroom Building | Good | Friable | Low | One | Seven |

Photo 29: HM-BB: 2' x 2' Drywall Ceiling Tile, White

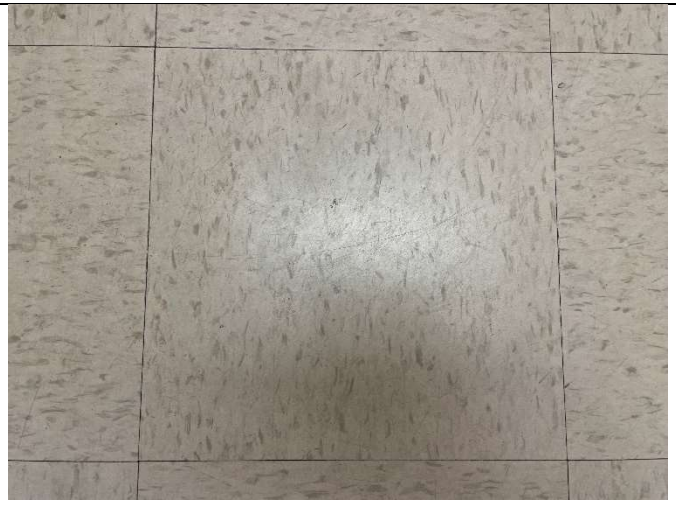
| Homog. Material | Material Description/Color | Material Location | Material Condition | Friability | Potential for Disturbance | Hazard Rank | Removal Rank |
|---|---|---|---|---|---|---|---|
| CC | 12" x 12" Vinyl Floor Tile, White with Gray Streaks | Classroom Building-Elevator | Good | Non- Friable | Low | One | Seven |

Photo 30: HM-CC: 12" x 12" Vinyl Floor Tile, White with Gray Streaks

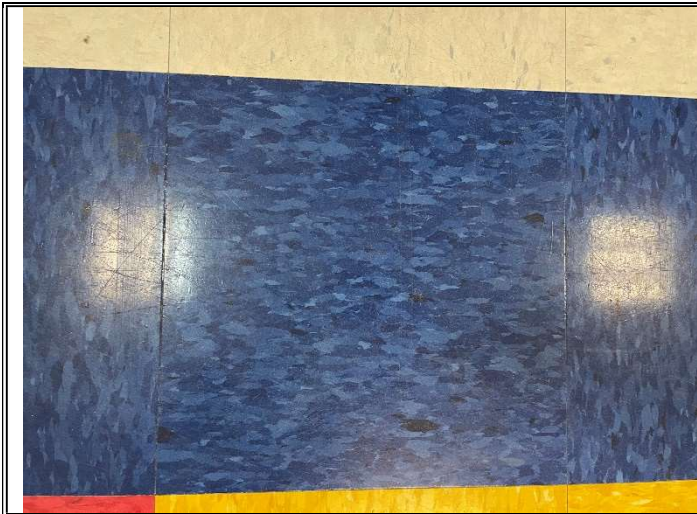
| Homog. Material | Material Description/Color | Material Location | Material Condition | Friability | Potential for Disturbance | Hazard Rank | Removal Rank |
|---|---|---|---|---|---|---|---|
| DD | 12" x 12" Vinyl Floor Tile, Navy Blue | Classroom Building | Good | Non- Friable | Low | One | Seven |

Photo 31: HM-DD: 12" x 12" Vinyl Floor Tile, Navy Blue

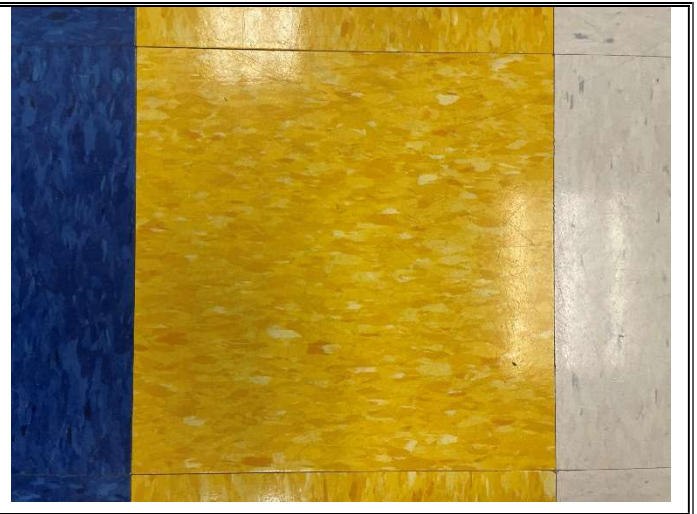
| Homog. Material | Material Description/Color | Material Location | Material Condition | Friability | Potential for Disturbance | Hazard Rank | Removal Rank |
|---|---|---|---|---|---|---|---|
| EE | 12" x 12" Vinyl Floor Tile, Yellow | Classroom Building | Good | Non- Friable | Low | One | Seven |

Photo 32: HM-EE: 12" x 12" Vinyl Floor Tile, Yellow

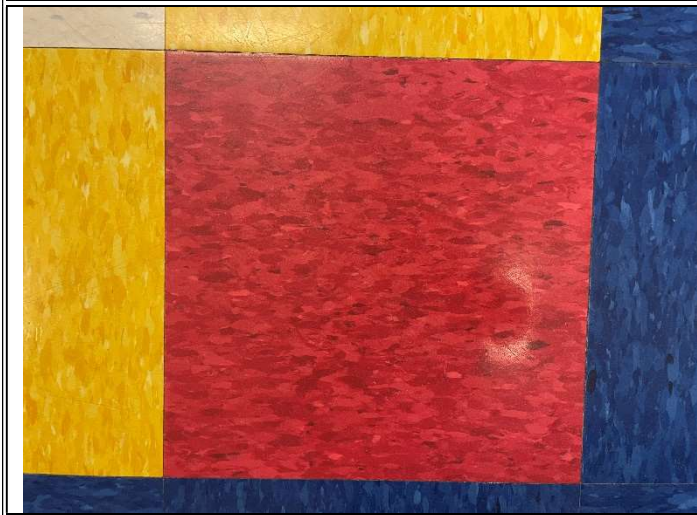
| Homog. Material | Material Description/Color | Material Location | Material Condition | Friability | Potential for Disturbance | Hazard Rank | Removal Rank |
|---|---|---|---|---|---|---|---|
| FF | 12" x 12" Vinyl Floor Tile, Red | Classroom Building | Good | Non- Friable | Low | One | Seven |

Photo 33: HM-FF: 12" x 12" Vinyl Floor Tile, Red

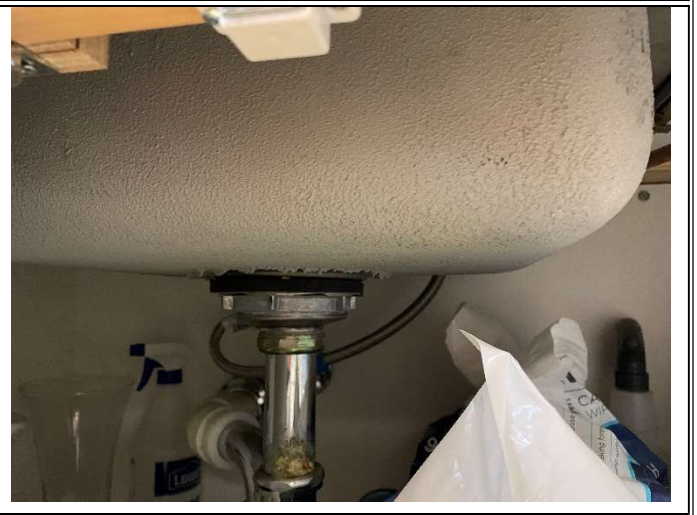
| Homog. Material | Material Description/Color | Material Location | Material Condition | Friability | Potential for Disturbance | Hazard Rank | Removal Rank |
|---|---|---|---|---|---|---|---|
| GG | Sink Insulation, Gray | Classroom Building | Good | Non- Friable | Low | One | Seven |

Photo 34: HM-GG: Sink Insulation, Gray

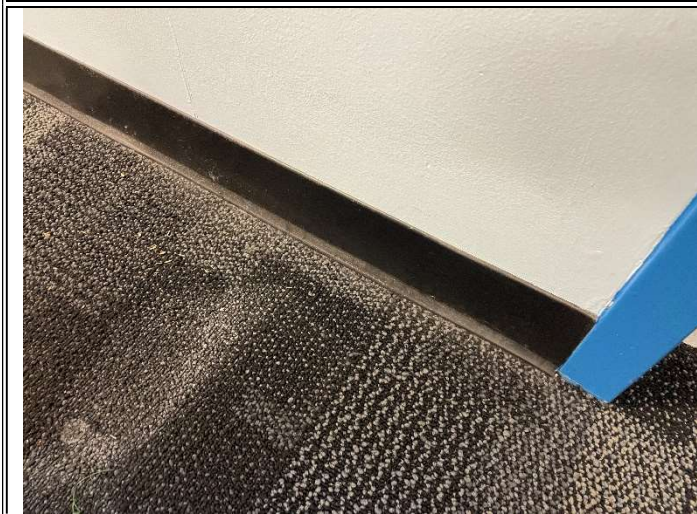
| Homog. Material | Material Description/Color | Material Location | Material Condition | Friability | Potential for Disturbance | Hazard Rank | Removal Rank |
|---|---|---|---|---|---|---|---|
| HH | Cove Base/Mastic, Black | Classroom Building | Good | Non- Friable | Low | One | Seven |

Photo 35: HM-HH: Cove Base/Mastic, Black

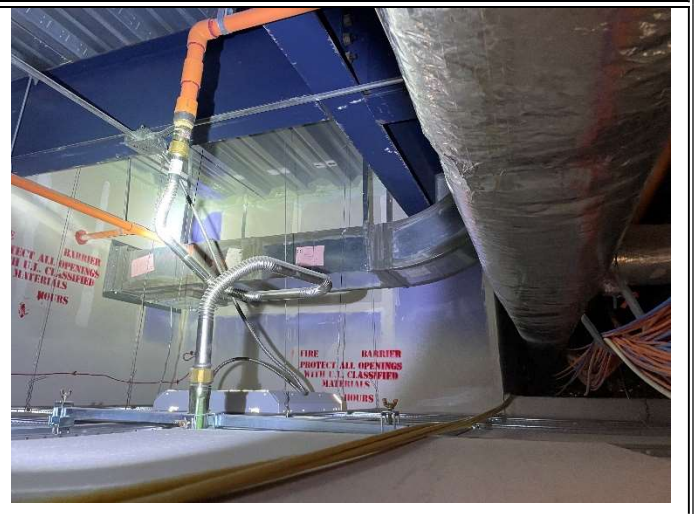
| Homog. Material | Material Description/Color | Material Location | Material Condition | Friability | Potential for Disturbance | Hazard Rank | Removal Rank |
|---|---|---|---|---|---|---|---|
| II | Duct Mastic, Gray | Classroom Building | Good | Non- Friable | Low | One | Seven |

Photo 36: HM-II: Duct Mastic, Gray
